# Monitoring of heavy metal subsurface contamination using trees

Arno Rein<sup>(1)</sup>, Ulrich Gosewinkel Karlson<sup>(2)</sup>, Carl Einar Amundsen<sup>(3)</sup>, Stefan Trapp<sup>(1)</sup>

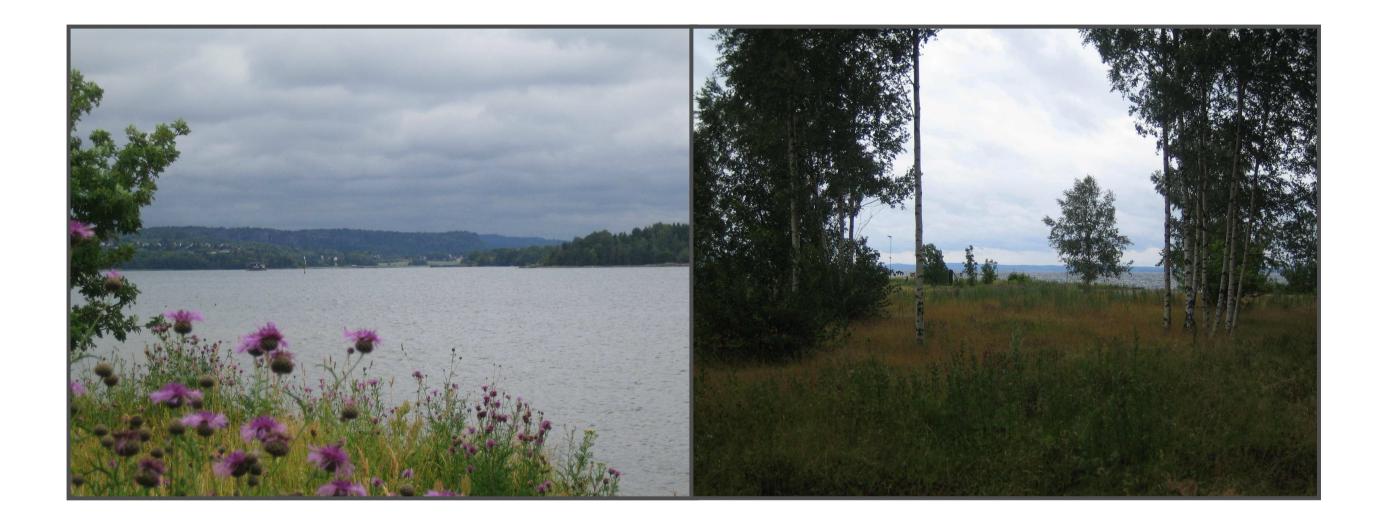
Correlation between tree cores and soil samples

1) all trees (mostly birch and willow; also cherry, aspen and ash):

> Positive correlation, but not significant for any metal

2) only willow trees (Salix caprea):

$\succ$  high and significant correlation for arsenic, cadmium and chromium
